022/2021

HVAC
TUBE SHEET
EROSION PROTECTION

TUBE SHEET
SEPTEMBER, 2013

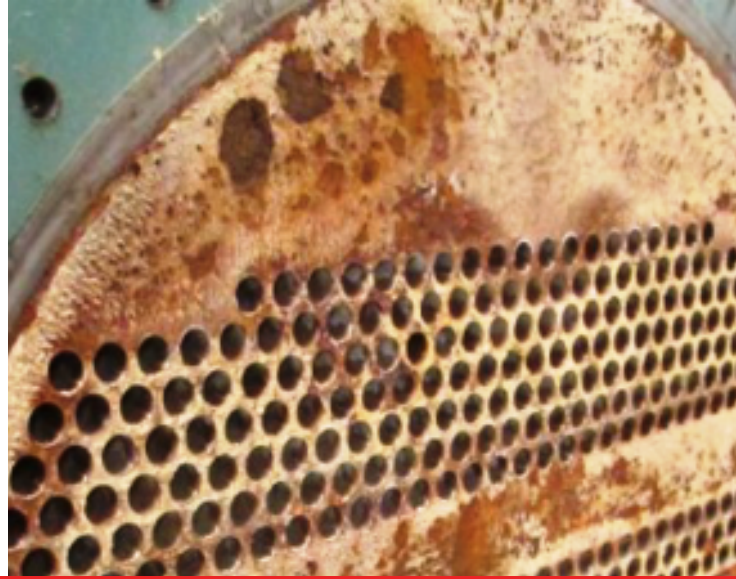
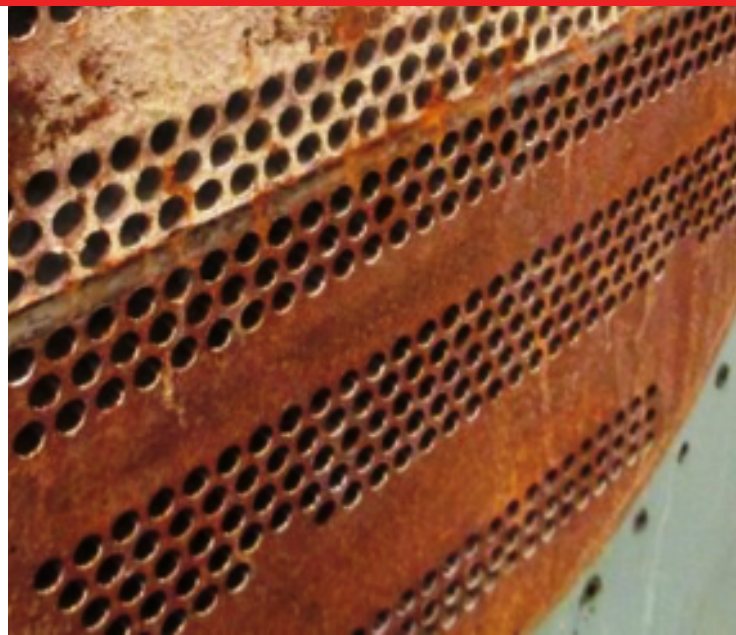
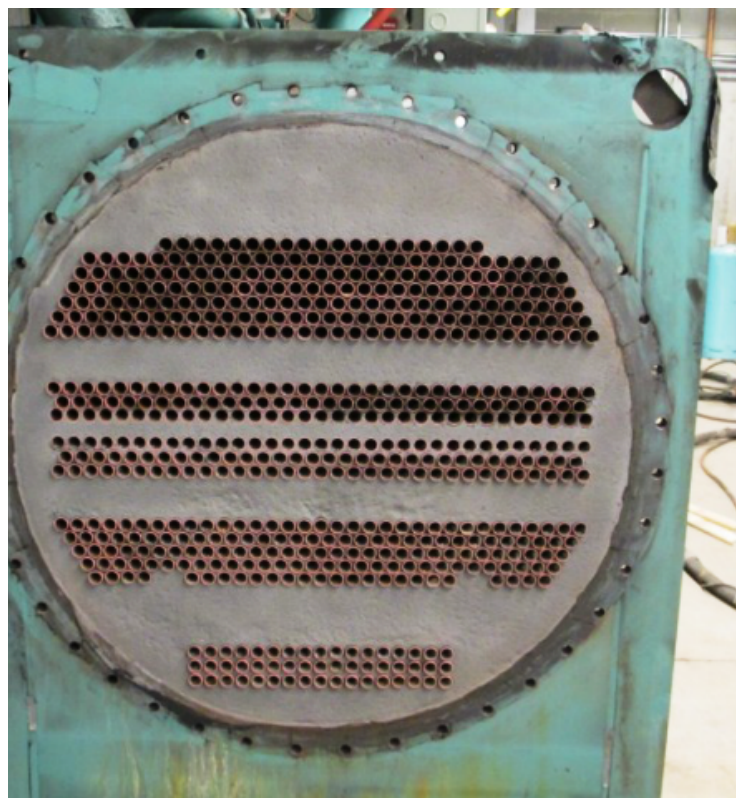
A hospital in Eastern Ontario was having issues with the tube sheet of their chiller. The chiller tube sheet was suffering from corrosion due to bi-metallic corrosion.

Chiller units are a vital part of any heating or air conditioning system. Failure to quickly protect these units allows galvanic corrosion to take place, resulting in wastage and metal loss on the tube sheet around the coolant tubes. Left untreated, the loss of metal can cause leakage of the coolant and contamination of the chilled water.

Belzona 1111 (Super Metal) was selected as the rebuilding material and Belzona 1321 (Ceramic S Metal) as the protective coating.

The surface was prepared by grit blasting and the surface was washed with Belzona 9111 (Cleaner Degreaser) to remove all residual blasting debris. The tubes were plugged with corks and Belzona 1111 (Super Metal) was applied to the area using an applicator. The first and second coat of Belzona 1321 (Ceramic S Metal) were applied with a short bristle brush in accordance with the Belzona Instructions For Use.
